MISCELLANEOUS PAPER GL-79-4

## EVALUATION OF THE EFFECTIVENESS OF MEMBRANES FOR PREVENTION OF CRACK REFLECTION IN THIN OVERLAYS

March 1979

Interim Report

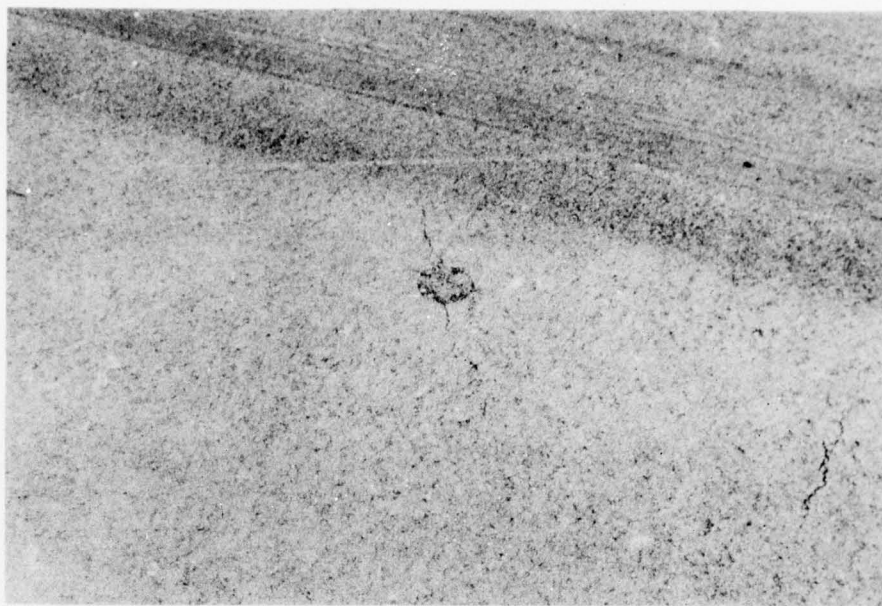
Photo 61. Fort Lewis--fine hairline crack created  
in overlay by wrinkle in Mirafi 140 fabric

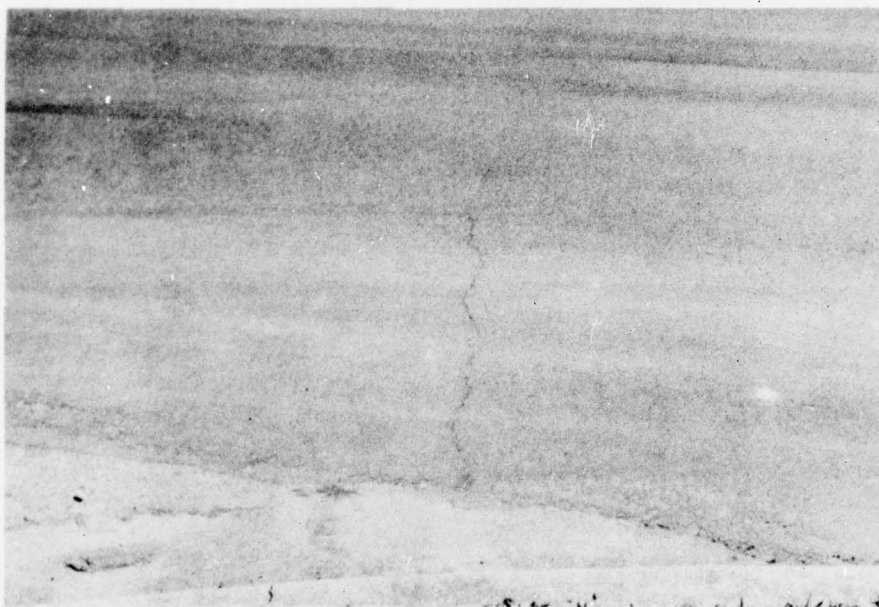
Photo 63. Fort Lewis--reflection crack in control  
section on north side of Faith Avenue

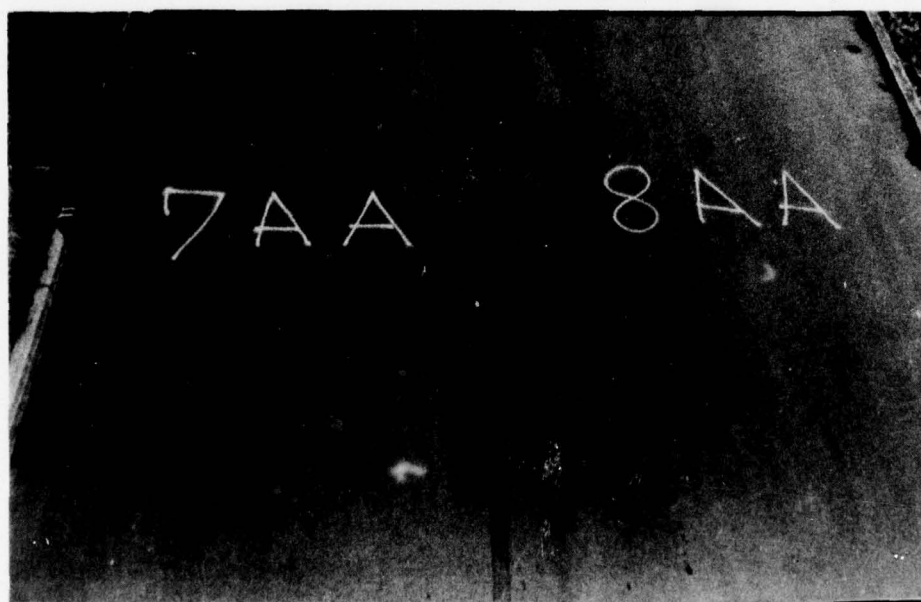
Photo 67. Fort Lewis--U. S. Rubber section,  
south side of Faith Avenue

a. Condition of surface prior to overlay

b. Condition of surface 6 months after overlay

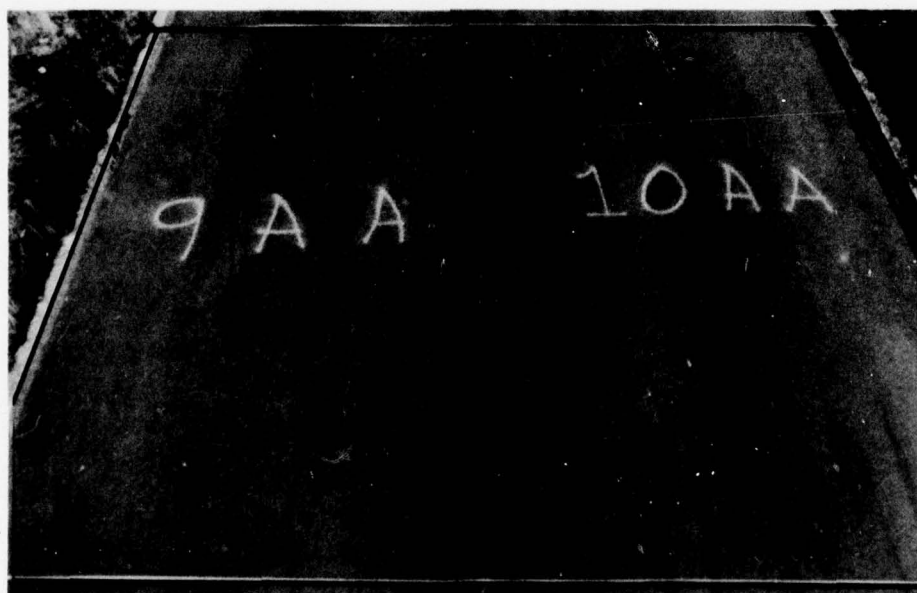
Photo 68. Fort Lewis--Mirafi 140 fabric section,  
south side of Faith Avenue

a. Condition of surface prior to overlay

b. Condition of surface 6 months after overlay

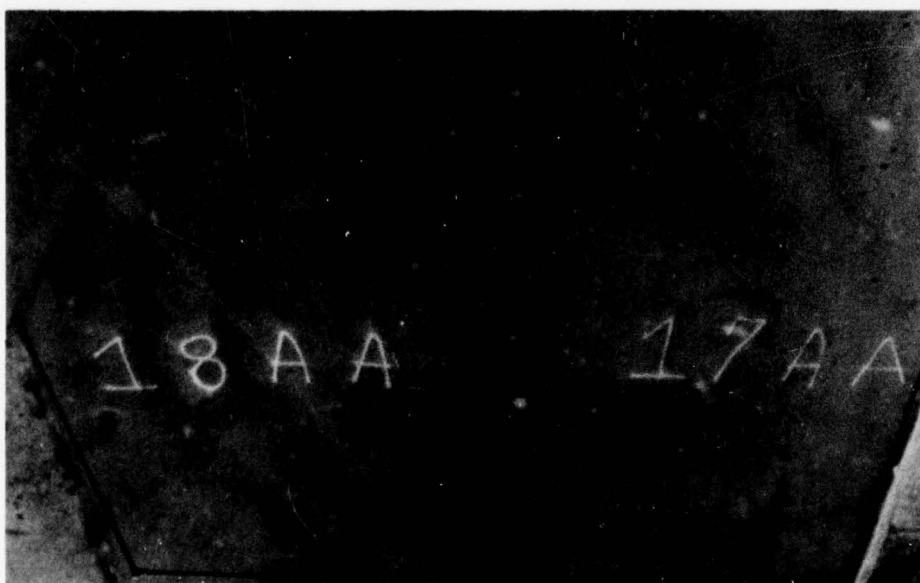
Photo 72. Fort Lewis--Bidim C-22 fabric section;  
north side of Faith Avenue

a. Condition of surface prior to overlay

b. Condition of surface 6 months after overlay

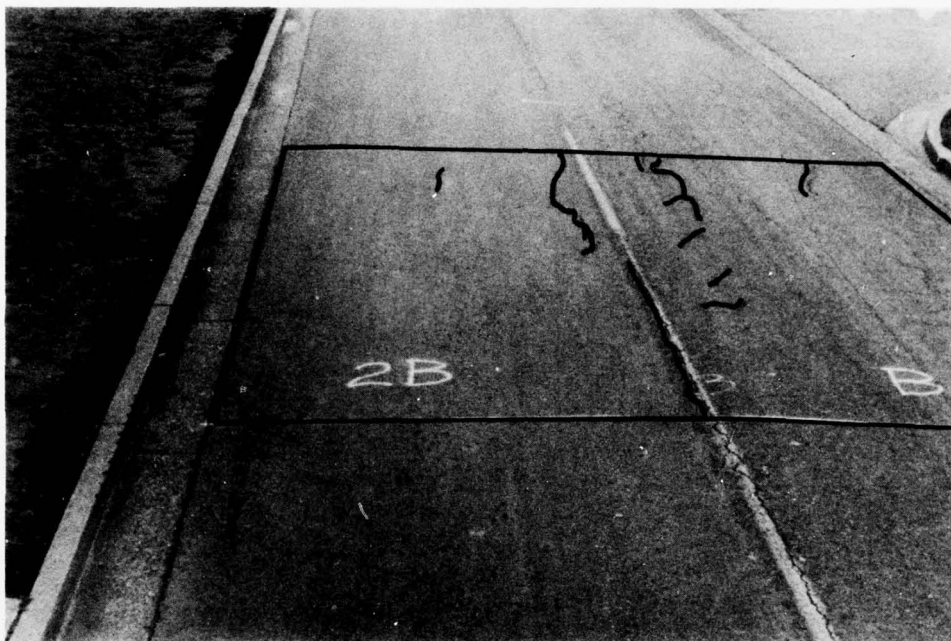
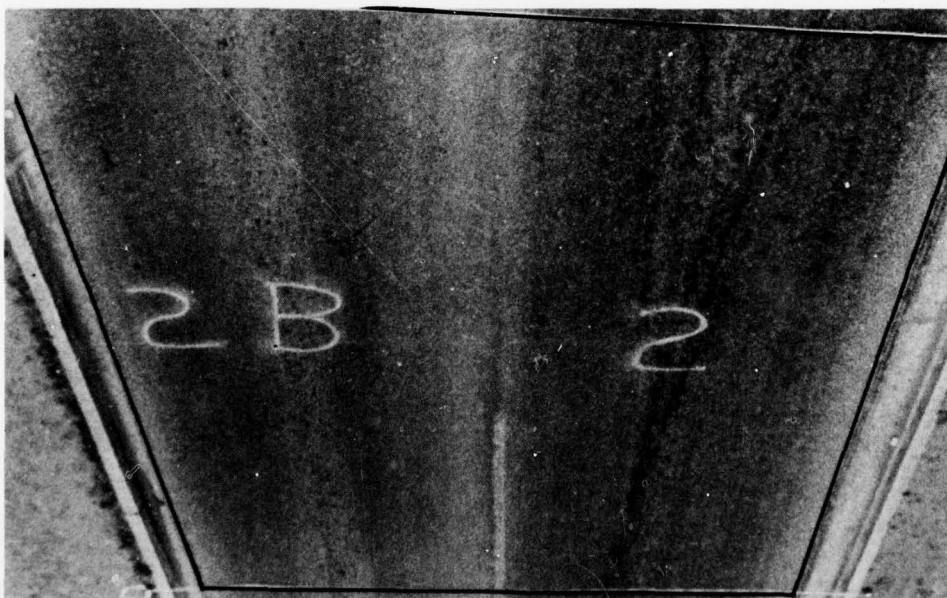
Photo 74. Fort Lewis--U. S. Rubber section,  
Second Division Drive

a. Condition of surface prior to overlay

b. Condition of surface 6 months after overlay

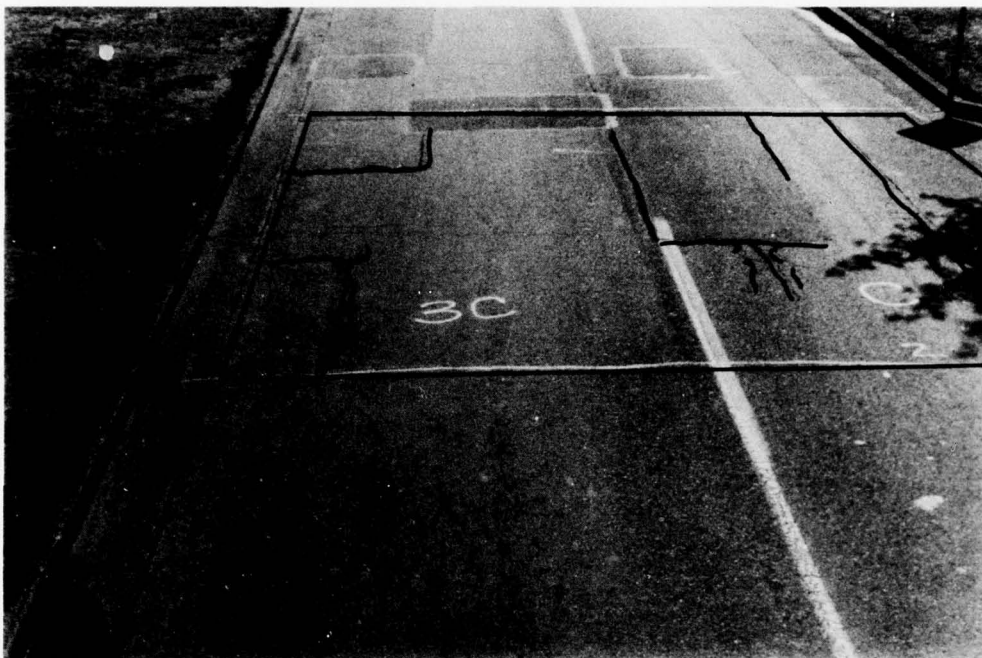
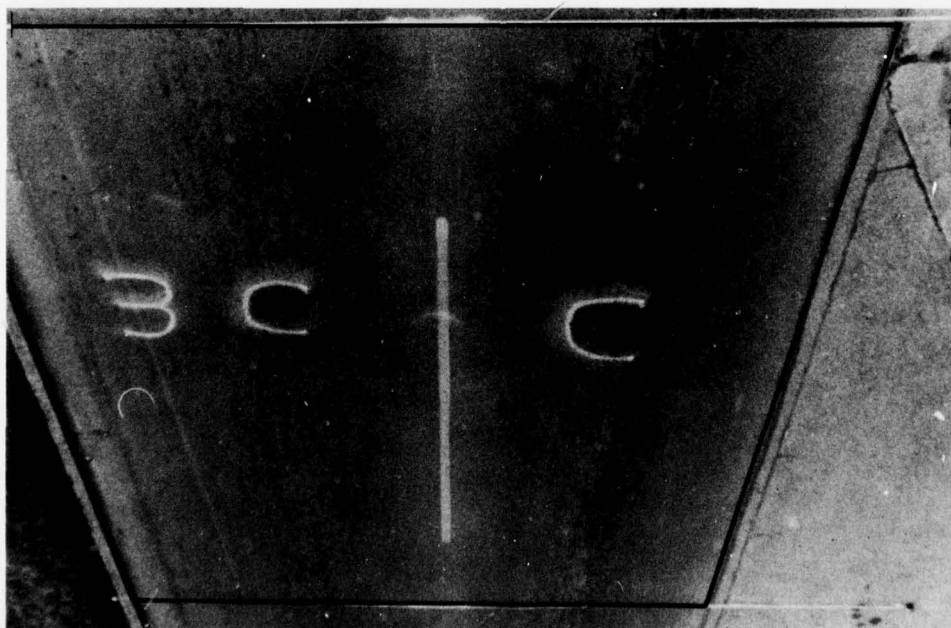
Photo 75. Fort Lewis--control section,  
Second Division Drive.

a. Condition of surface prior to overlay

b. Condition of surface 6 months after overlay

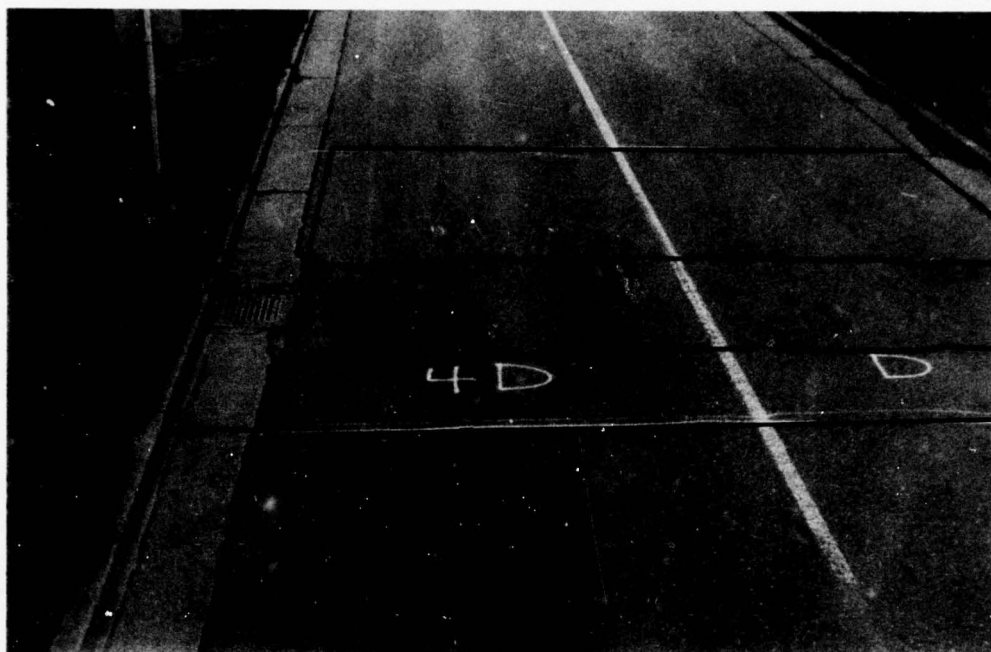
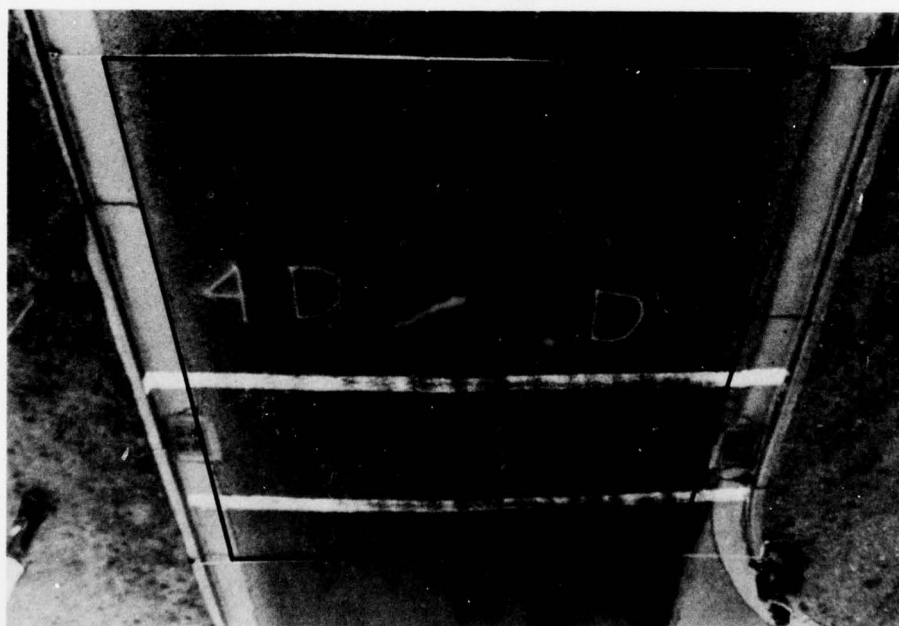
Photo 76. Fort Lewis--Sahuaro rubber section,  
Second Division Drive

a. Condition of surface prior to overlay

b. Condition of surface 6 months after overlay

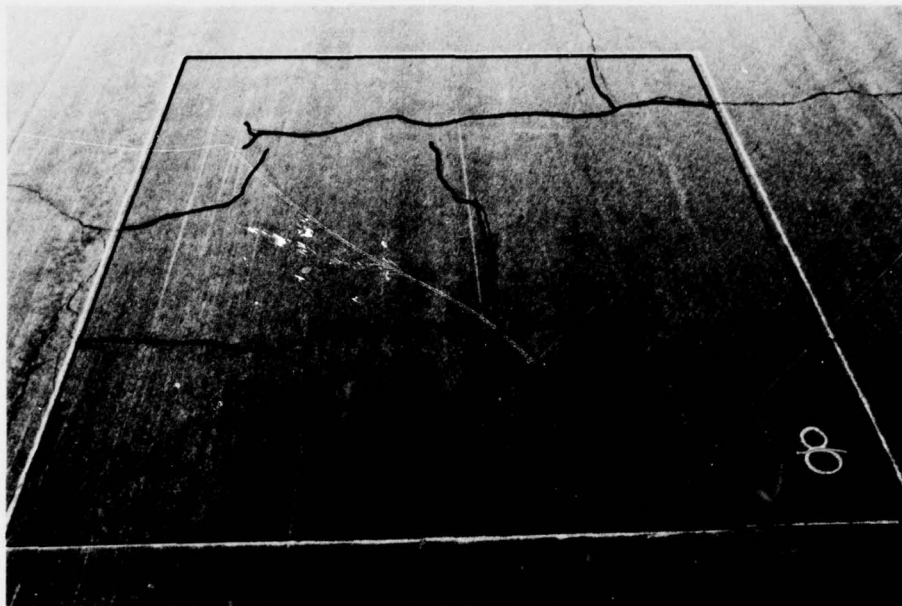
Photo 98. Fort Devens--control section (south),  
N-S runway

49. The survey to monitor the performance of the various test sections at Fort Devens was made on 7 June 1978. It was reported that the 1977-78 winter was one of the coldest this area has experienced in the past 50 years. Photos 91-107 indicate the crack pattern that existed in the selected photographic areas on the airfield prior to placement of overlay and 6 months after the placement of the overlay. No cracking was noted in the selected areas for the 6-month survey. A total of five transverse cracks in the entire length of the NW-SE runway were observed to have reflected for the area treated with the U. S. Rubber asphalt-rubber membrane (Photo 108). On the NW-SE runway (Photo 109), five transverse cracks were observed in the two 200-ft-long control sections. The small gouged area on the N-S runway (Photo 110), in the Mirafi 140 test area, apparently was caused by a locked wheel turn of an aircraft. The overlay slipped on the fabric and formed the resulting depression. Photos 111-115 indicate the cracking pattern for Barnum Road; and as noted, no cracks have reflected in the selected areas. Some cracking was found in the overlay surface of Barnum Road outside of the test areas (Photo 116).

a. Condition of surface prior to overlay

b. Condition of surface 6 months after overlay

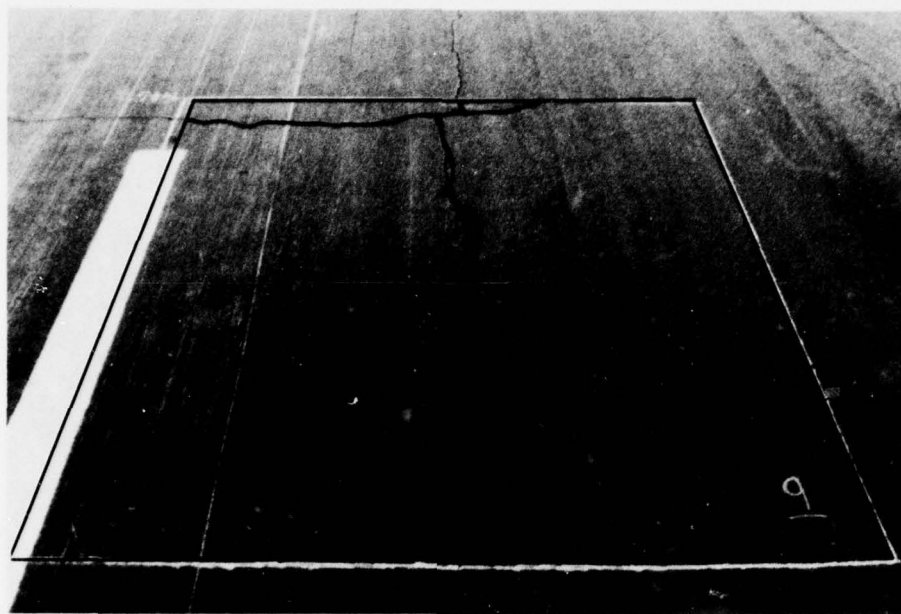
Photo 99. Fort Devens--Bidim C-22 fabric section,  
N-S runway

a. Condition of surface prior to overlay

b. Condition of surface 6 months after overlay

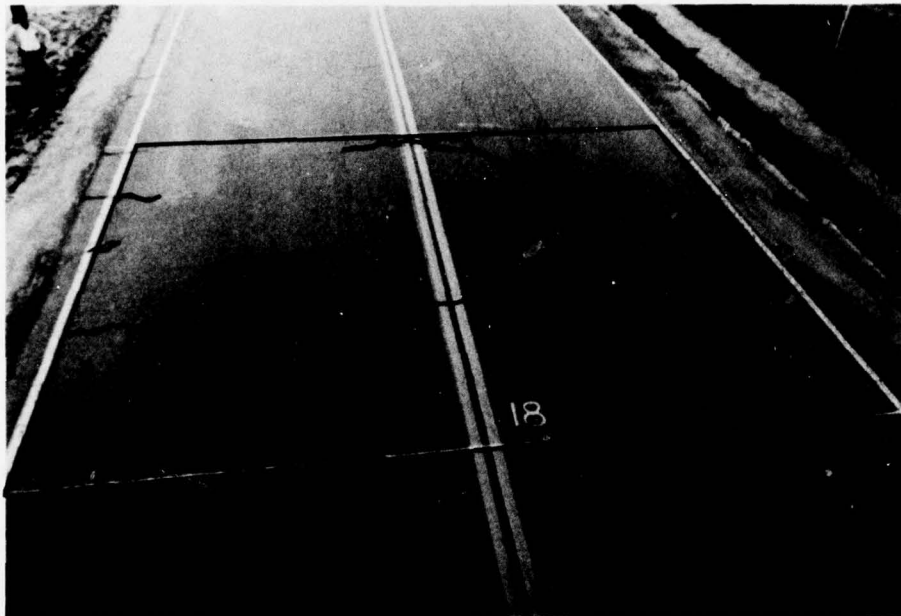
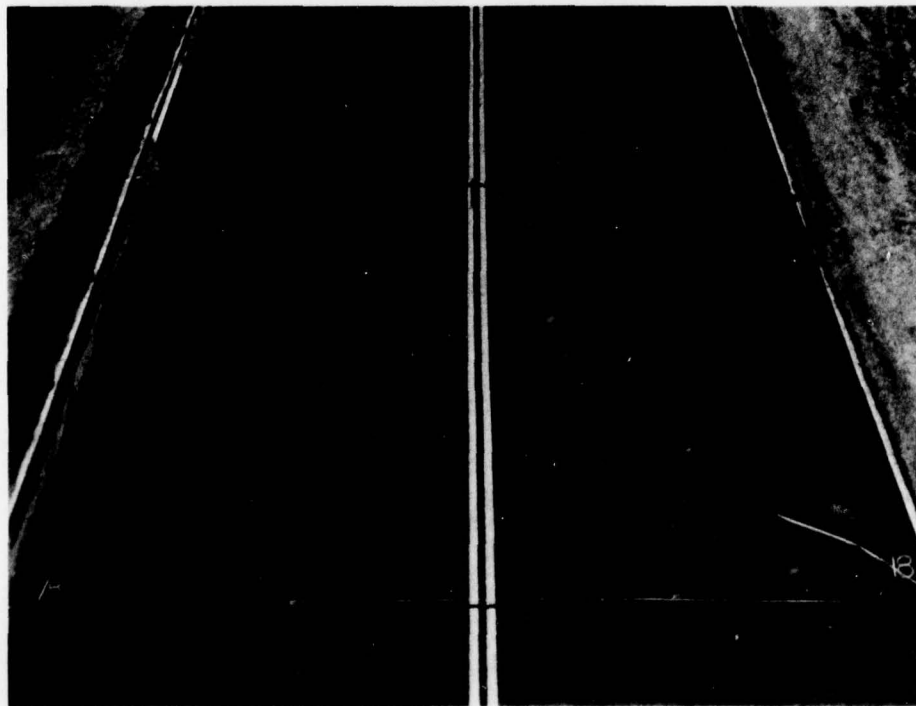
Photo 111. Fort Devens--Sahuaro rubber section,  
Barnum Road

a. Condition of surface prior to overlay

b. Condition of surface 6 months after overlay

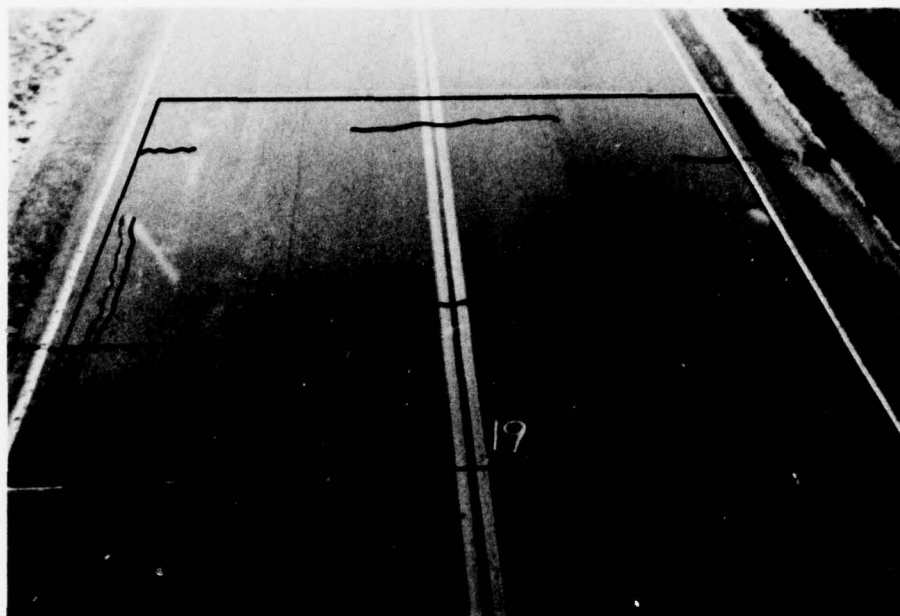
Photo 112. Fort Devens--U. S. Rubber section,  
Barnum Road

a. Condition of surface prior to overlay

b. Condition of surface 6 months after overlay

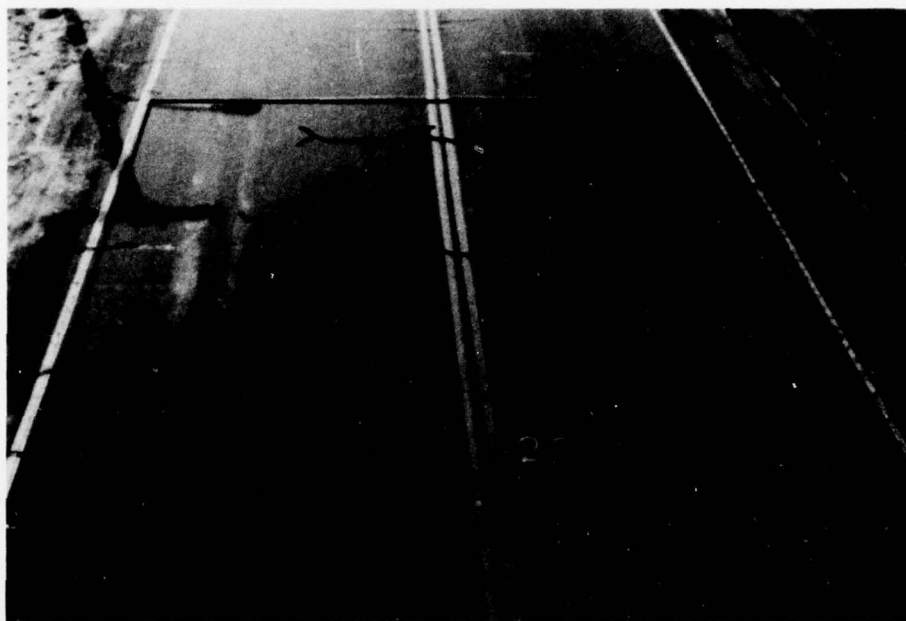
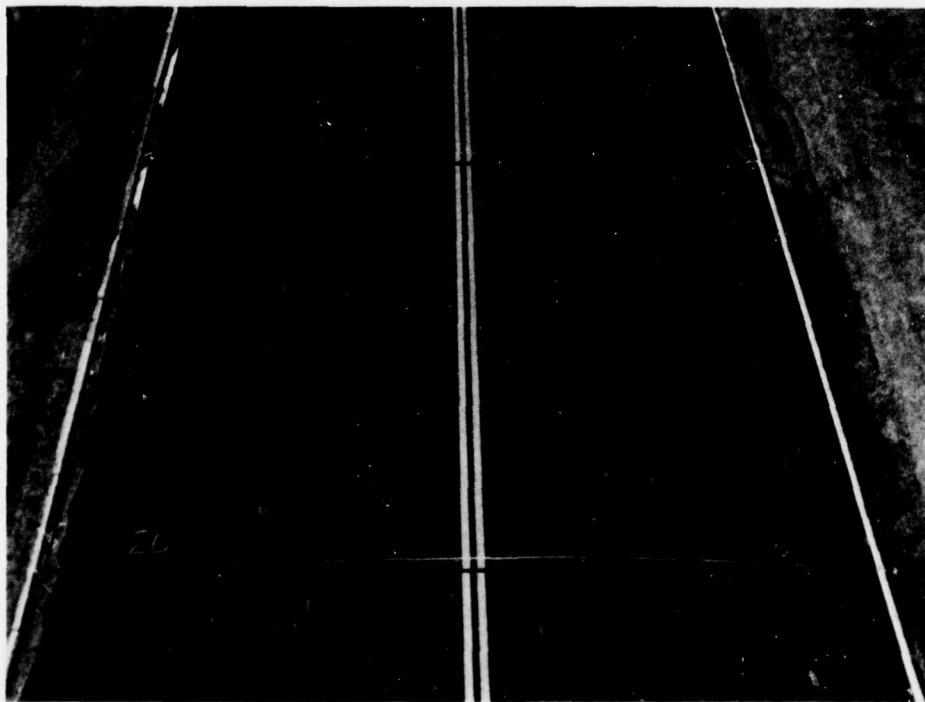
Photo 113. Fort Devens--Mirafi 140 fabric section,  
Barnum Road

a. Condition of surface prior to overlay

b. Condition of surface 6 months after overlay

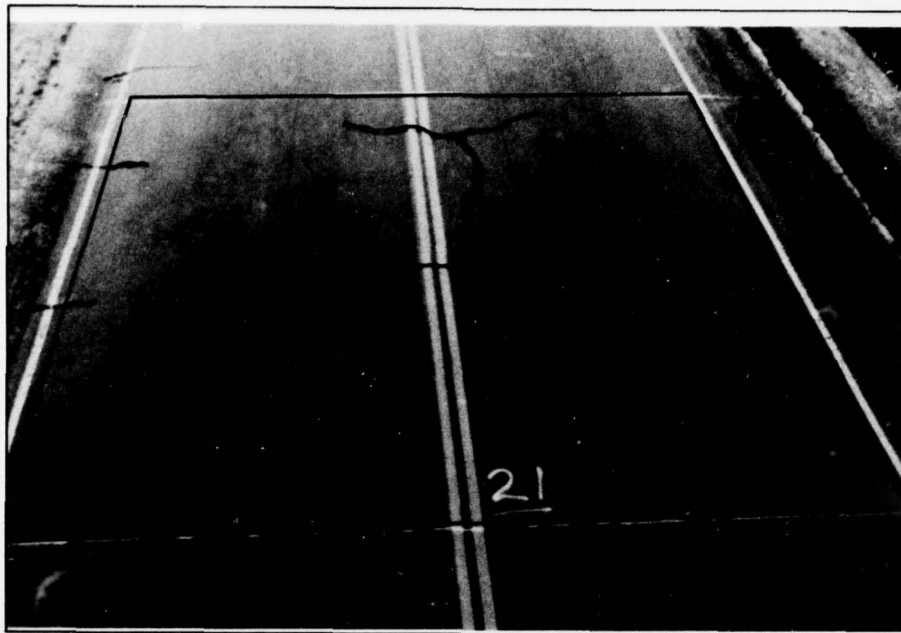
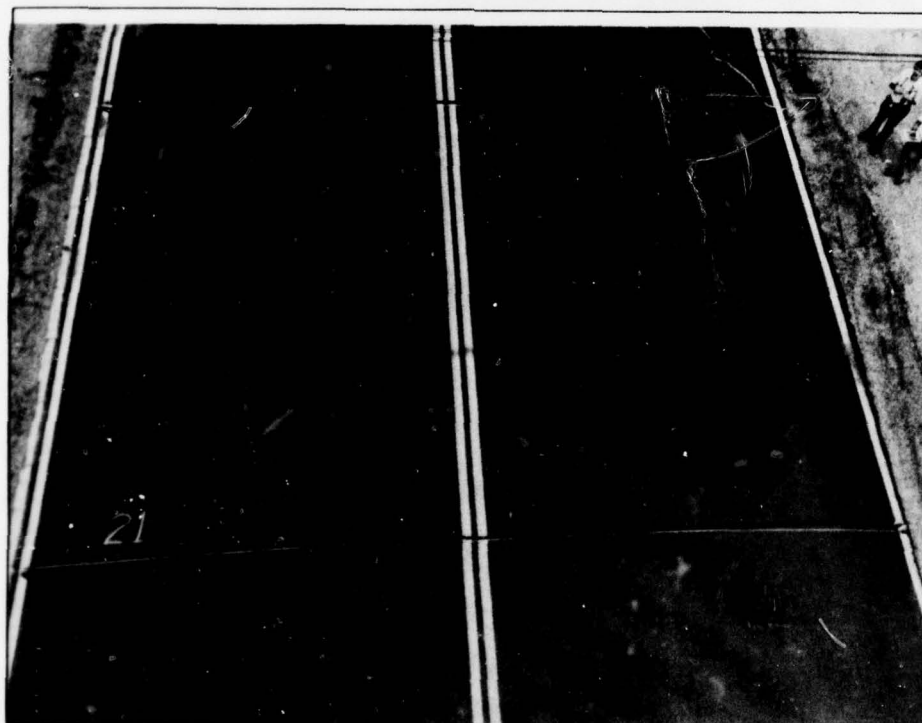
Photo 114. Fort Devens--Bidim C-22 fabric section,  
Barnum Road

a. Condition of surface prior to overlay

b. Condition of surface 6 months after overlay

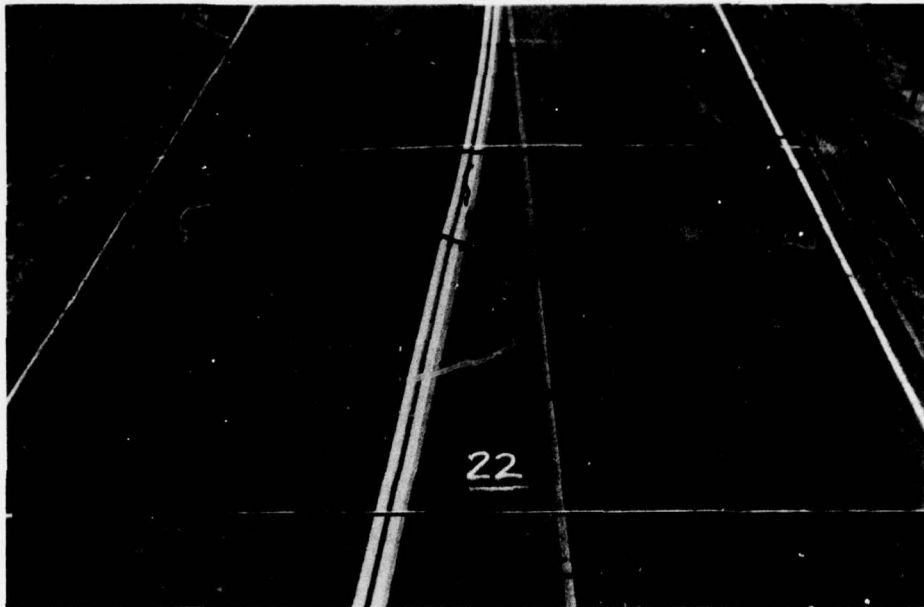
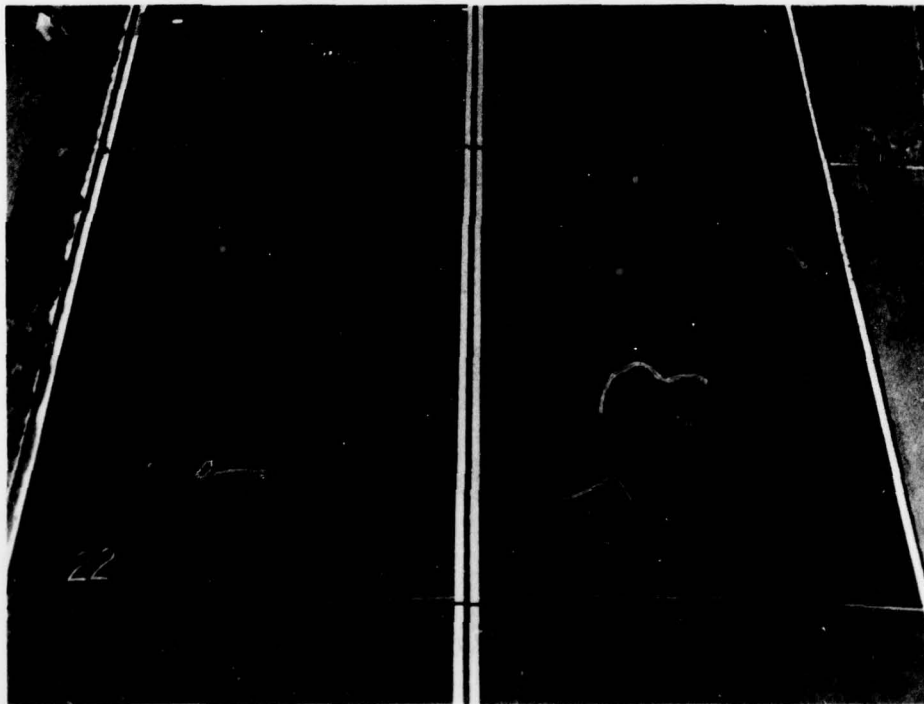
Photo 115. Fort Devens--control section, Barnum Road

a. Condition of surface prior to overlay

b. Condition of surface 6 months after overlay

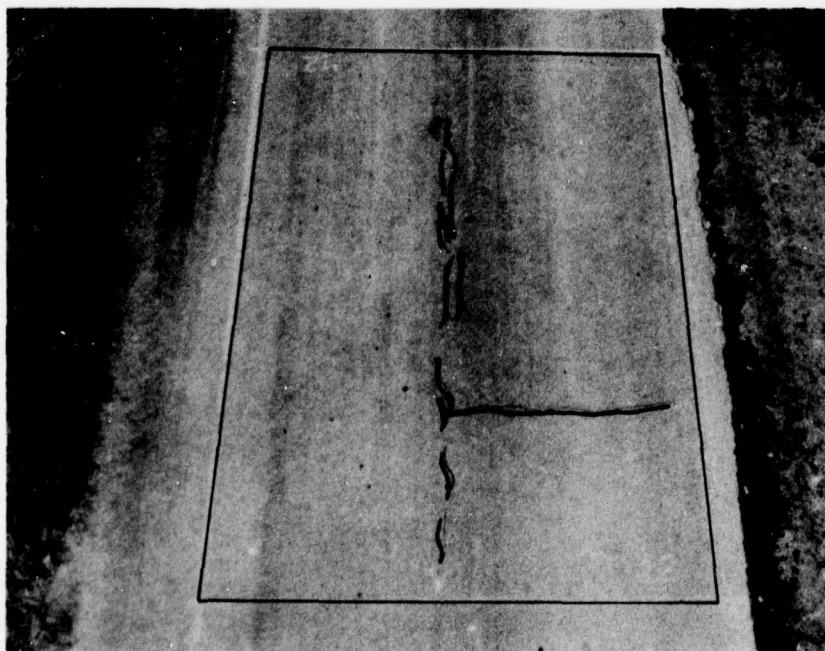
50. Results of the crack survey for the condition of Wilderness Road prior to the placement of the overlay are presented in Photos 117-128 and the corresponding transparencies for these photographs. A survey to determine the performance of the test areas will be made in the spring of 1979, approximately 1 year after placement of the materials.

Photo 128. Fort Carson--condition of test area No. 12  
prior to overlay
